South Carolina Department of
Natural Resources

2019

Summary of Living Shoreline Research to Inform Regulatory Decision-Making in South Carolina

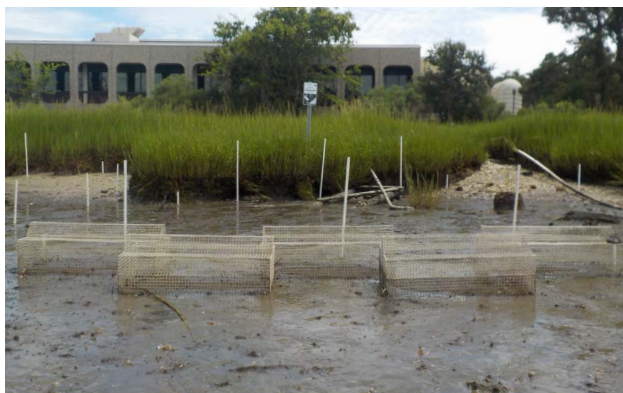
Figure 3.7. Manufactured wire reefs (MWRs) were developed as an option similar to repurposed crab traps.

MWRs are 4 ft (1.2 m) long, 2 ft (0.61 m) wide, and 18 in (45.7 cm) high. They are manufactured with these dimensions to create more surface area for larval oyster recruitment compared with crab traps (2 ft x 2 ft x 2 ft; 0.61 m x 0.61 m x 0.61 m). MWRs are installed on the intertidal bank halfway between the waterward marsh edge and the mean low water line to provide optimal conditions for oyster survival and productivity (Figure 3.8). SCDNR tested MWRs in a staggered checkerboard-like pattern to maximize surface area while creating one contiguous structure. They are secured to the sediment using #3 J-bar rebar that is at least 24 inches long and has a 4-inch candy cane bend, which is placed into the sediment through the mesh of the reef at four points (two on each side), holding the reef in place on the bank. These structures are well-suited for sites where the sediment is too soft for traditional reef materials such as bagged oyster shell. MWR units are also much lighter than bagged shell, take less effort to install, and, due to the finite supply of oyster shell, are likely to be a more viable option for installing oyster-based living shorelines at a commercial scale.

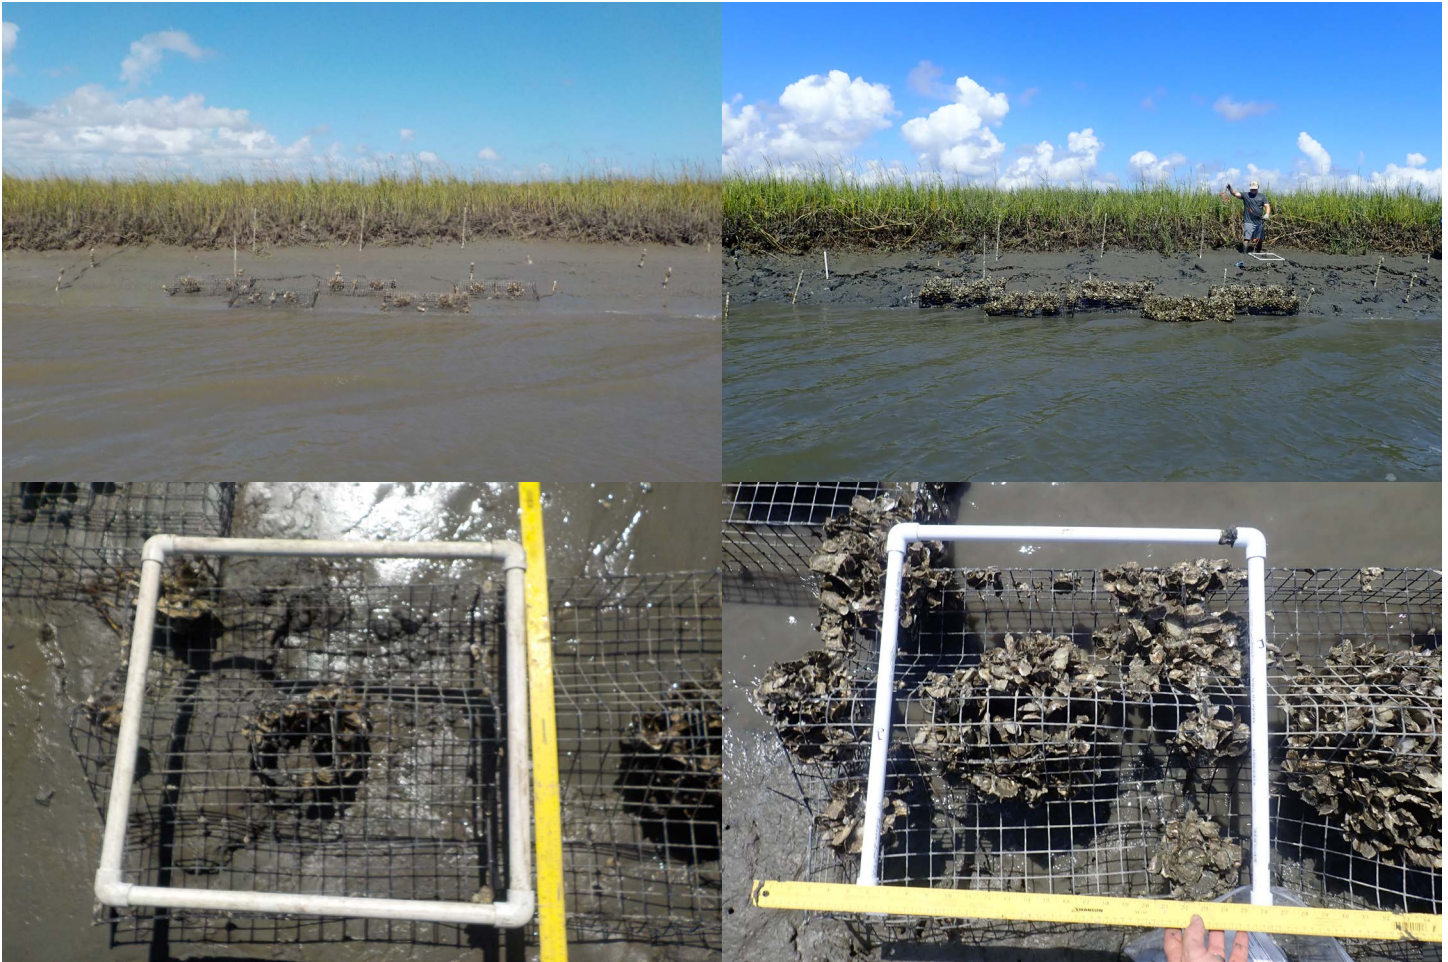
Figure 3.9. Live oyster coverage on MWRs at Big Bay Creek in October 2017 (one year post-install; left) and September 2018 (two years post-install; right).

During the first two years following installation, a total of 3.7 in (9 cm) of fine sediment accumulated on the bank immediately upslope of the reef, and 4.8 in (12 cm) of sediment accumulated on the bank 1 ft (30 cm) upslope of the reef. During this same time period, the sediment surface elevation at a nearby control area decreased by 2.7 in (7 cm). This treatment has successfully maintained its location on the bank, with no sliding downslope. Oyster recruitment and growth, on the surface of the wire, increased markedly from 11% at one year post-installation (less than at the shell bag reef at this site) to 54% at two years post-installation (greater than at the shell bag reef at this site; Figure 3.9). As seen in a photo taken in May 2019, 34 months after installation, marsh expansion has started to occur at this location (Figure 3.10).

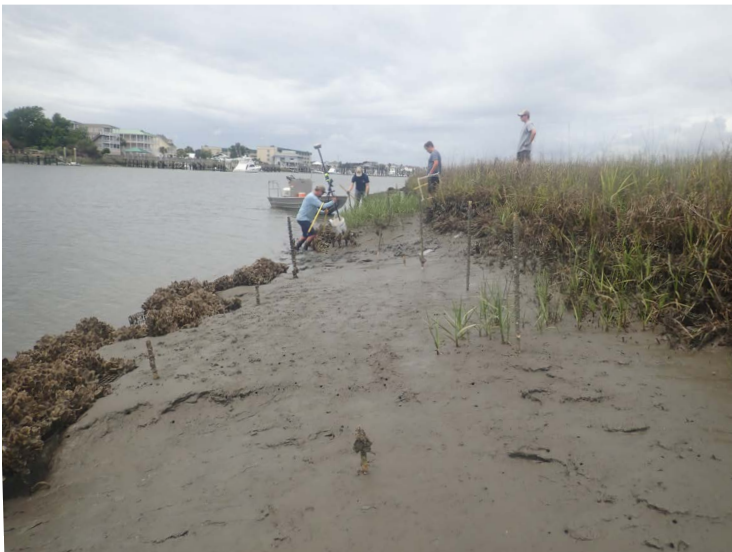
Figure 3.10. Almost 3 years after installation of the MWR at Big Bay Creek, oyster cover and growth continue to increase, and marsh expansion was starting to occur. Photo taken in May 2019.

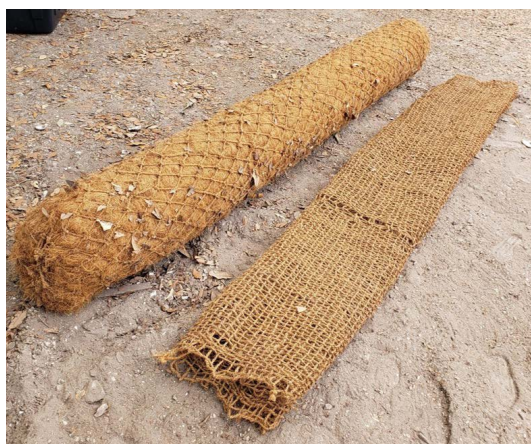
Figure 3.13. Coir log (10 ft length x 16 in diameter; 3 m x 41 cm) with a single-layer tube of coir netting with smaller openings and additional netting placed under the coir log to reduce sinking of the log into the sediment.

Coir logs are biodegradable cylinders of compressed coconut husk fiber, also known as coir (Figure 3.13). They are available in a variety of lengths and widths but are typically sold in 10 ft (3.0 m) lengths. Coir logs are wrapped in a coir or jute netting that contains the compressed coir. SCDNR has found it useful to wrap the coir log in an additional layer of coir netting with smaller openings to better contain the compressed coir fibers and lengthen the life span of the coir logs in the estuarine environment (Figure 3.13). A folded underlayment of coir fabric is also beneficial at sites with soft or very soft sediment. This underlayment reduces the amount that the coir log sinks into the soft sediment.

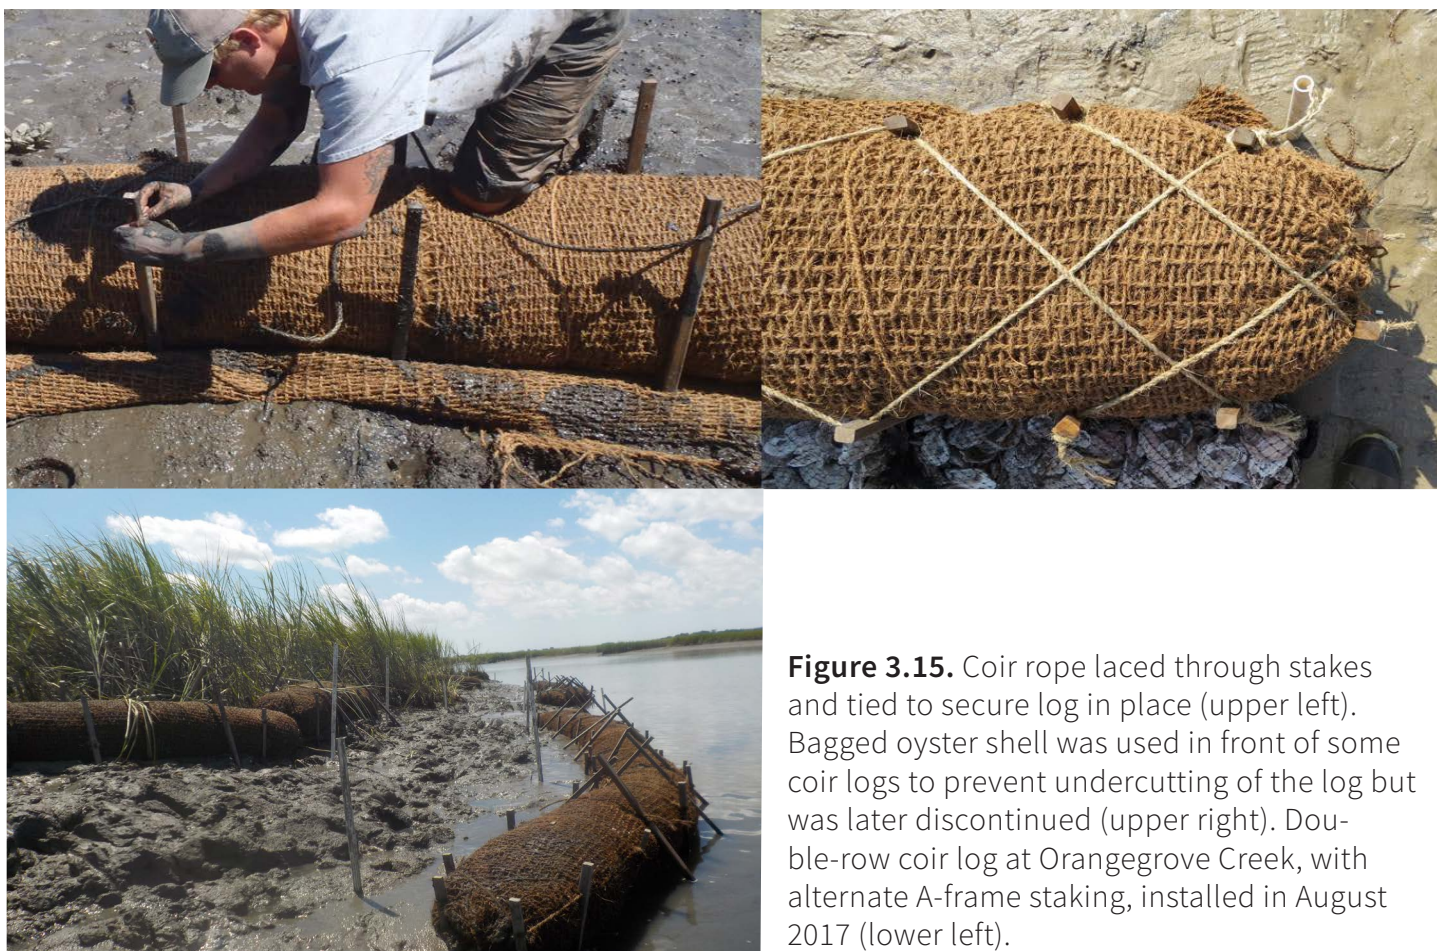
Figure 3.15. Coir rope laced through stakes and tied to secure log in place (upper left). Bagged oyster shell was used in front of some coir logs to prevent undercutting of the log but was later discontinued (upper right). Double-row coir log at Orangecreek, with alternate A-frame staking, installed in August 2017 (lower left).

Regardless of their installation location, it is imperative that coir logs are securely staked and tied in place. This can be done using rot-resistant wooden stakes with a hole drilled a few inches from the top through which to pass coir twine. Stakes are pounded into the sediment through the folded coir mat resting under the log at 1-ft (0.3 m) intervals around the perimeter. Coir twine is laced through the stakes with care to ensure the stakes and coir twine are touching the log. Stakes are then pounded further into the sediment until the coir twine is pressed tightly into the top surface of the log in order to reduce potential vertical movement of the log (Figures 3.14 and 3.15). Additional stakes should be installed inward, in an A-frame configuration, where the stakes are touching the coir log near the top surface and coming in contact with each other in the air space over the top center surface of the coir log. A-frame stakes do not need eye holes for twine; the stakes themselves will hold the log against the bank. The combination of vertical and A-frame staking will prevent the log from sliding downslope (vertical stakes) and prevent vertical movement of the log in response to wave energy (A-frame stakes), which can lead to the twine wearing and breaking (Figures 3.14 and 3.15). Coir logs that are not properly secured to the bank can go missing within one tidal cycle regardless of the site conditions.

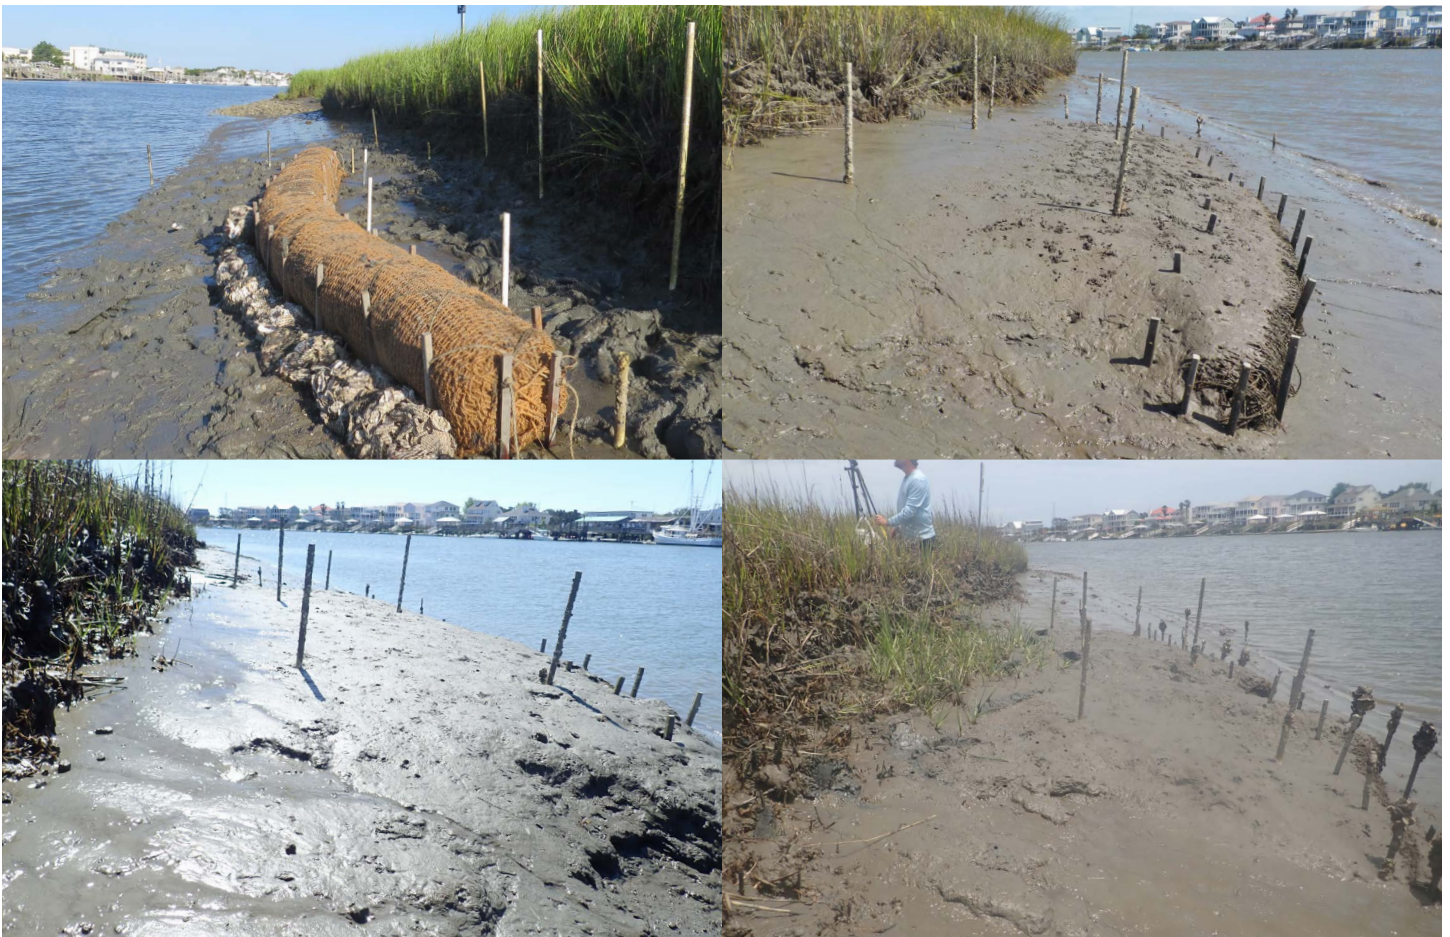
Figure 3.16. A single-row coir log treatment at Big Bay Creek (Figure 3.4) in July 2016 (upper left), October 2017 (upper right), September 2018 (lower left), and May 2019 (lower right).

During the first two years following installation, a total of 10.8 in (27 cm) of fine sediment accumulated on the bank immediately upslope of the reef, and 10.9 in (28 cm) of sediment accumulated on the bank 1 ft (30 cm) upslope of the reef. During this same time period, the sediment surface elevation at a nearby control area decreased by 2.7 in (7 cm). Most of the sediment accumulation occurred during the first year after installation (Figure 3.16). Even though the slope was steep and the baseline sink depth was high, the stakes and coir twine were successful at holding the treatment in position on the bank; this could be due to the relatively coarse sediment (65% sand) present on the intertidal bank at baseline. Approximately 3 years after installation (May 2019), natural (not planted) marsh grass has begun to colonize the bank behind the coir log (Figure 3.16, lower right).

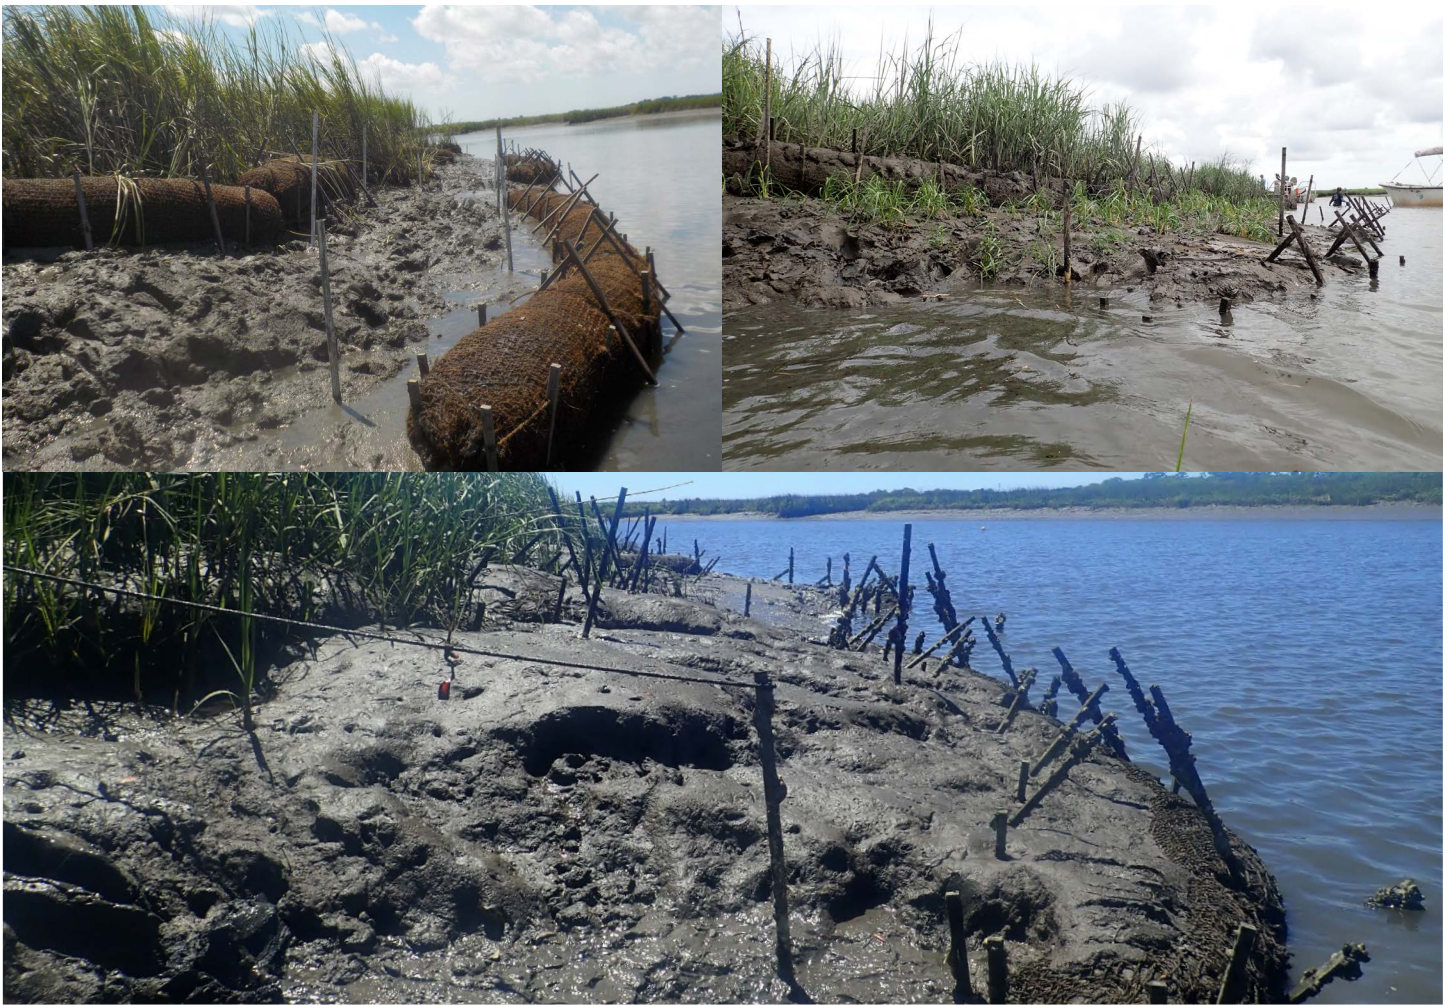
Figure 3.17. Double-row coir log treatment at Orangegrove Creek in August 2017 (upper left), May 2018 (upper right), and April 2019 (lower). The upper left coir log went missing at some point between August 2018 and April 2019.

During the first 20 months post-installation, a total of 6.2 in (16 cm) of fine sediment accumulated on the bank 1 ft (30 cm) upslope of the bottom row of coir logs (Figure 3.17). During this same time period, an average of 7.5 in (19 cm) of sediment elevation was lost at a nearby negative control area. One of the coir logs in the escarpment edge row, at some point between monitoring in August 2018 and April 2019, broke away from its stakes and went missing (Figure 3.17). While a significant amount of sediment had accumulated at this treatment site, no marsh expansion has been observed to date.

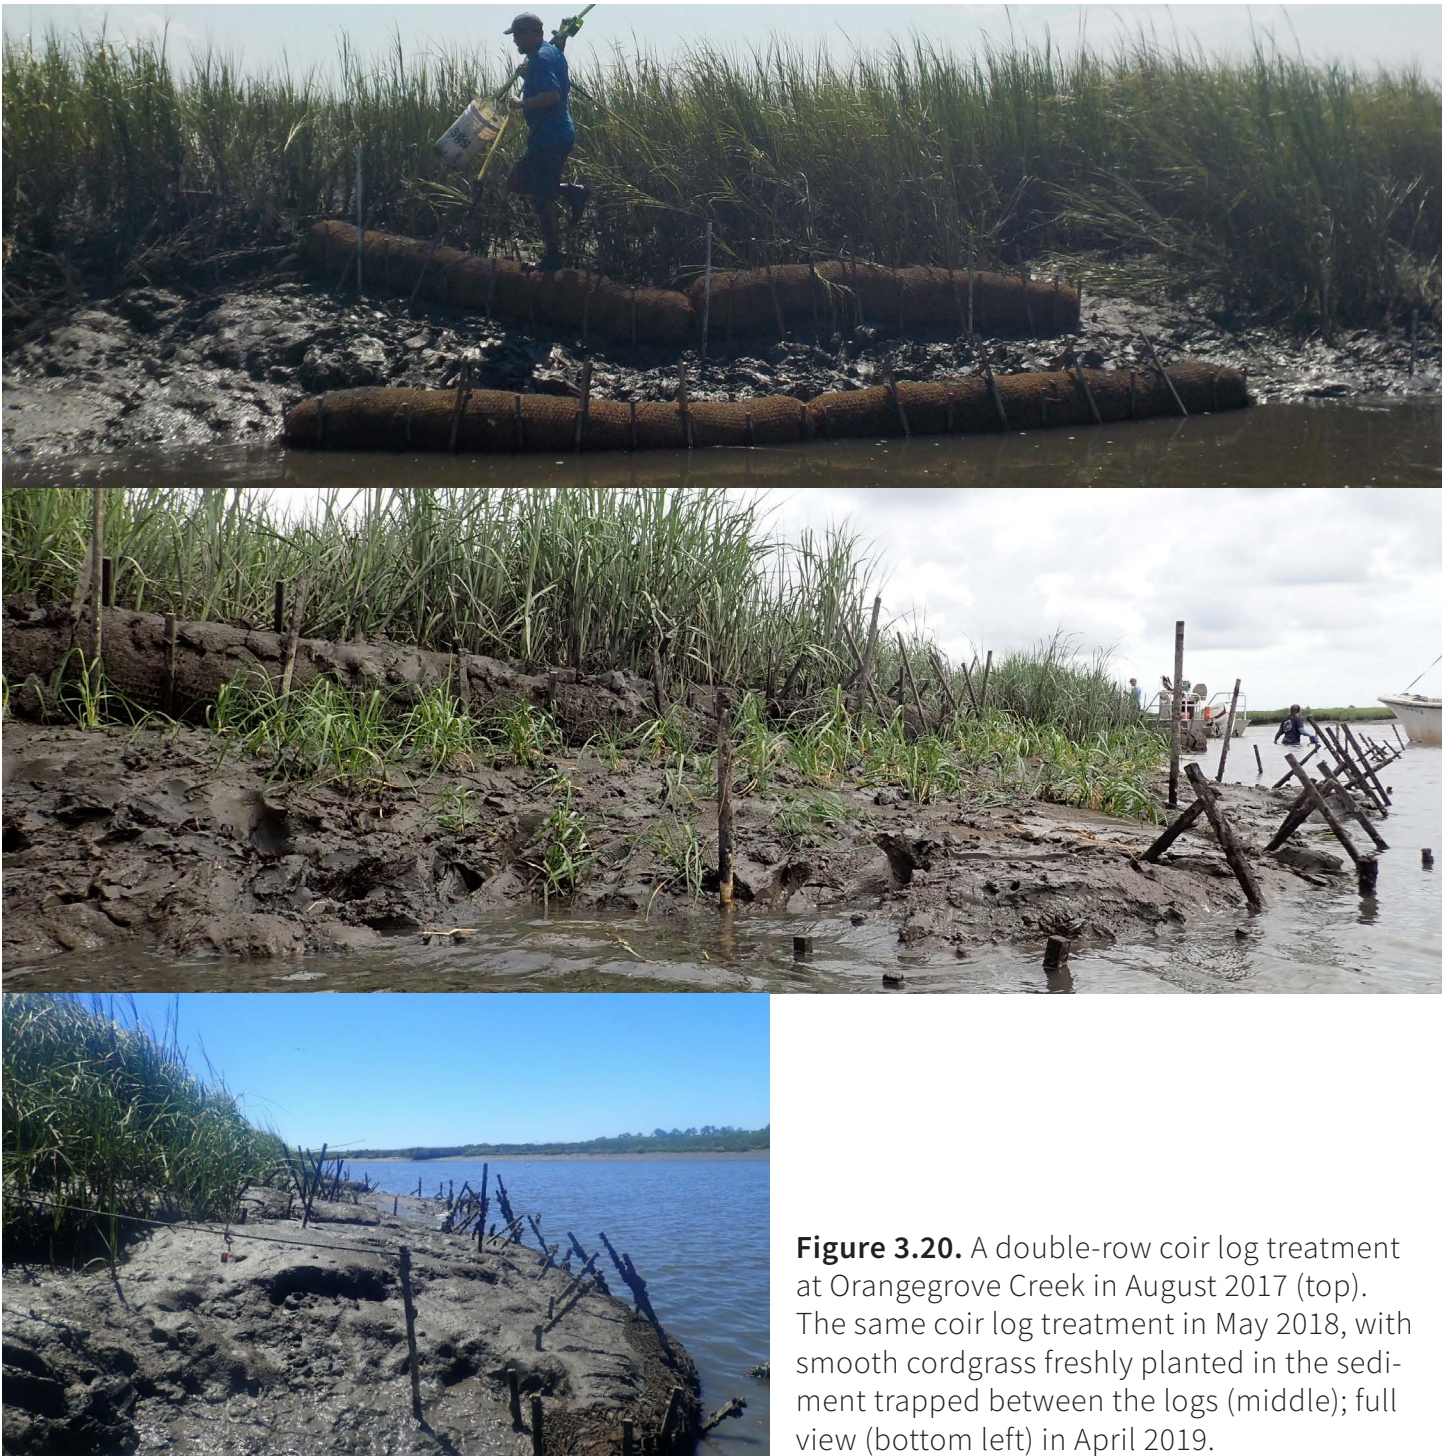
Figure 3.20. A double-row coir log treatment at Orangegroove Creek in August 2017 (top). The same coir log treatment in May 2018, with smooth cordgrass freshly planted in the sediment trapped between the logs (middle); full view (bottom left) in April 2019.

At the gap between the rows of coir logs on the left-hand side of the planted treatment, it appears that some of the sediment that had accumulated between the logs became destabilized and collapsed down the slope (Figure 3.20); this loss of sediment stability may have been associated with the loss of some of the planted smooth cordgrass or disturbance during monitoring. The steep slope (31%) and high silt/clay sediment (98% silt/clay and 2% sand) where the planted double coir log treatment was installed provided challenging conditions for a living shoreline installation. However, if the smooth cordgrass along the upper row of logs can establish and expand further downslope, this treatment may provide some level of shoreline stabilization.

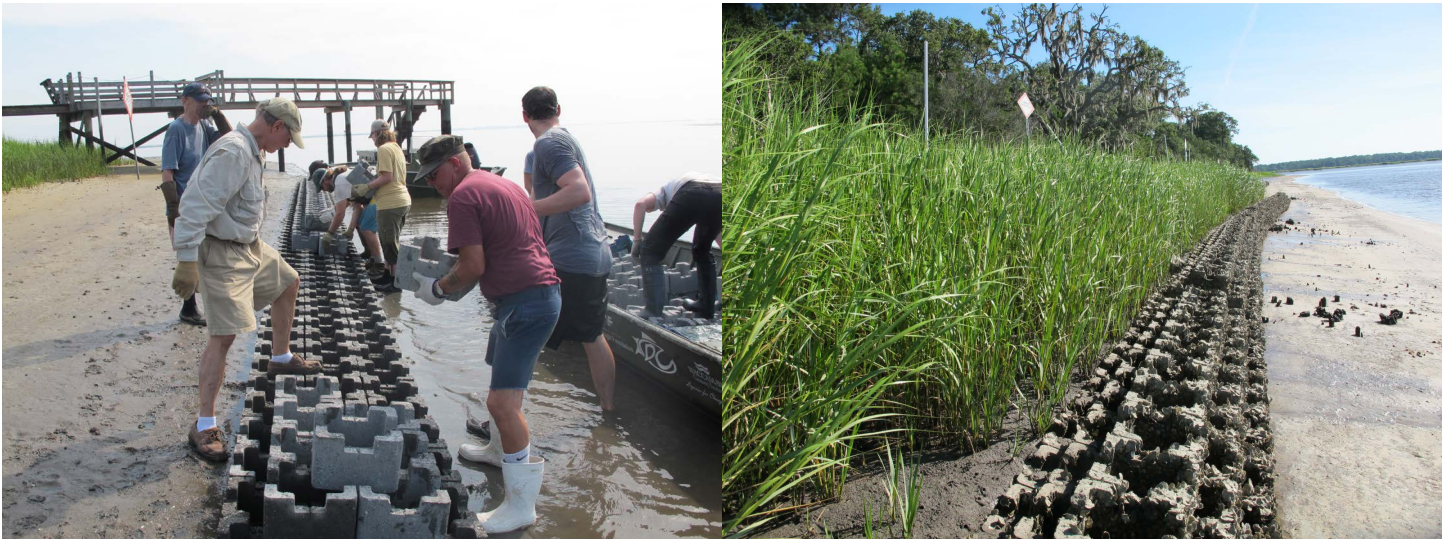
Figure 3.21. Oyster castle reef on Lucy Point Creek, near Beaufort, SC, shown during construction (left) and Coosaw River, near Beaufort, SC, shown 2 years after construction (right).

Oyster castles present an additional option for providing substrate that attract oysters and can trap sediment to create habitat and support shoreline stabilization. These concrete-based structures are produced by Allied Concrete Inc. and have been used by The Nature Conservancy in a number of states along the East Coast, including South Carolina in collaboration with SCDNR since 2011. The interlocking nature of oyster castles allows for flexible spatial configurations (including vertical stacking) along the shoreline (Figure 3.21). This vertical relief can be effective in buffering the shoreline from onshore wave energy associated with boat wakes, as well as natural forces (e.g., wind, tides, and currents). However, oyster castles can only be used in low-slope and firm shorelines. The interstitial spaces provided by these 3-dimensional structures are beneficial in providing habitat for a number of reef-associated organisms, such as blue crabs.

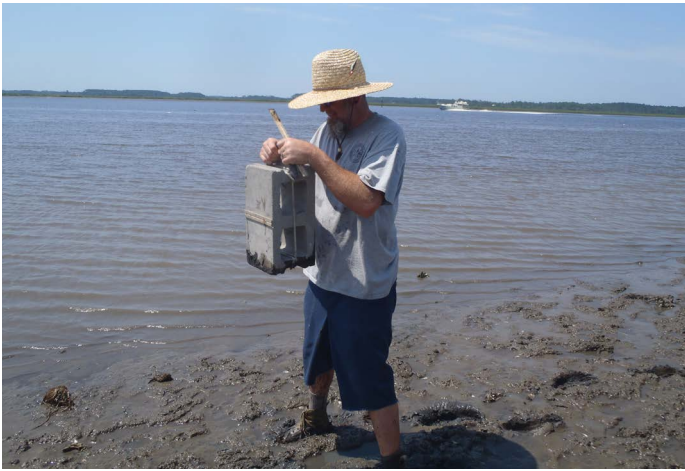
Figure 4.3. An image of the sink depth method used for this study.

Assessing the firmness of sediment will aid in selecting which living shoreline material will be most suitable. To assess sediment firmness or sink depth, researchers held a standard cinderblock approximately 3 ft (1 m) above the sediment surface at the intended living shoreline location and dropped it (Figure 4.3). At the upslope edge of the indentation made by the cinderblock, the vertical distance was measured from the bottom of the indentation to the top edge, providing the sink depth. Sink depth can be used to categorize sediment firmness as very firm (<1.97 in or 5 cm), firm (1.97-3.90 in or 5-9.9 cm), soft (3.94-5.91 in or 10-15 cm), or very soft (>5.91 in or 15 cm). For this study, a threshold of 10 cm was used for differentiating firm from soft.

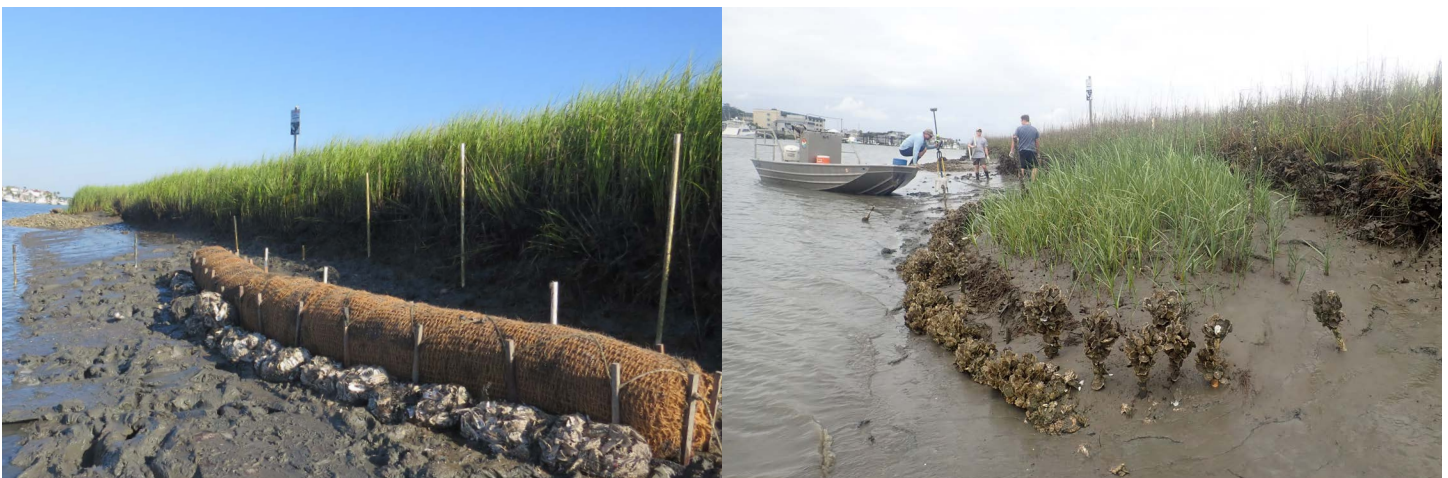
Figure 5.2. Single-row coir log treatment with a single row of shell bags, installed in July 2016 along Big Bay Creek (left). This treatment was planted with smooth cordgrass in April 2018 and photographed in May 2019 (right)

There is anecdotal information to indicate that combining coir logs with oyster shell bags or MWRs may be beneficial. Based on guidance from the mid-Atlantic region (Partnership for the Delaware Estuary), a single row of oyster shell bags (shell bolsters) were placed in front of a subset of coir logs with the goal of limiting undercutting of coir logs. No undercutting was observed at coir log treatments installed without shell bags in this study; however, it was noted that at higher salinity sites, a single row of shell bags often successfully recruited and grew oysters (Figure 5.2). Coir logs were effective at capturing sediment but are expected to have a limited lifespan (< 5 years) in the estuarine environment. It seems likely that the presence of an oyster reef along the downslope edge of a coir log could increase the likelihood that the sediment trapped by a coir log remains in place after the coir log degrades. Additionally, coir logs may improve the performance of shell bag reefs when certain site conditions are present. At sites with high slopes and soft sediment, shell bag treatments, even when placed on wooden pallets, often became partially covered with sediment (Figure 5.3), reducing the surface area for oyster recruitment and growth. At high slope sites, placing a row of coir logs immediately upslope of a shell bag reef may reduce sediment deposition on the top surface of the shell bags and thereby increase the proportion of the reef area covered in living oysters.

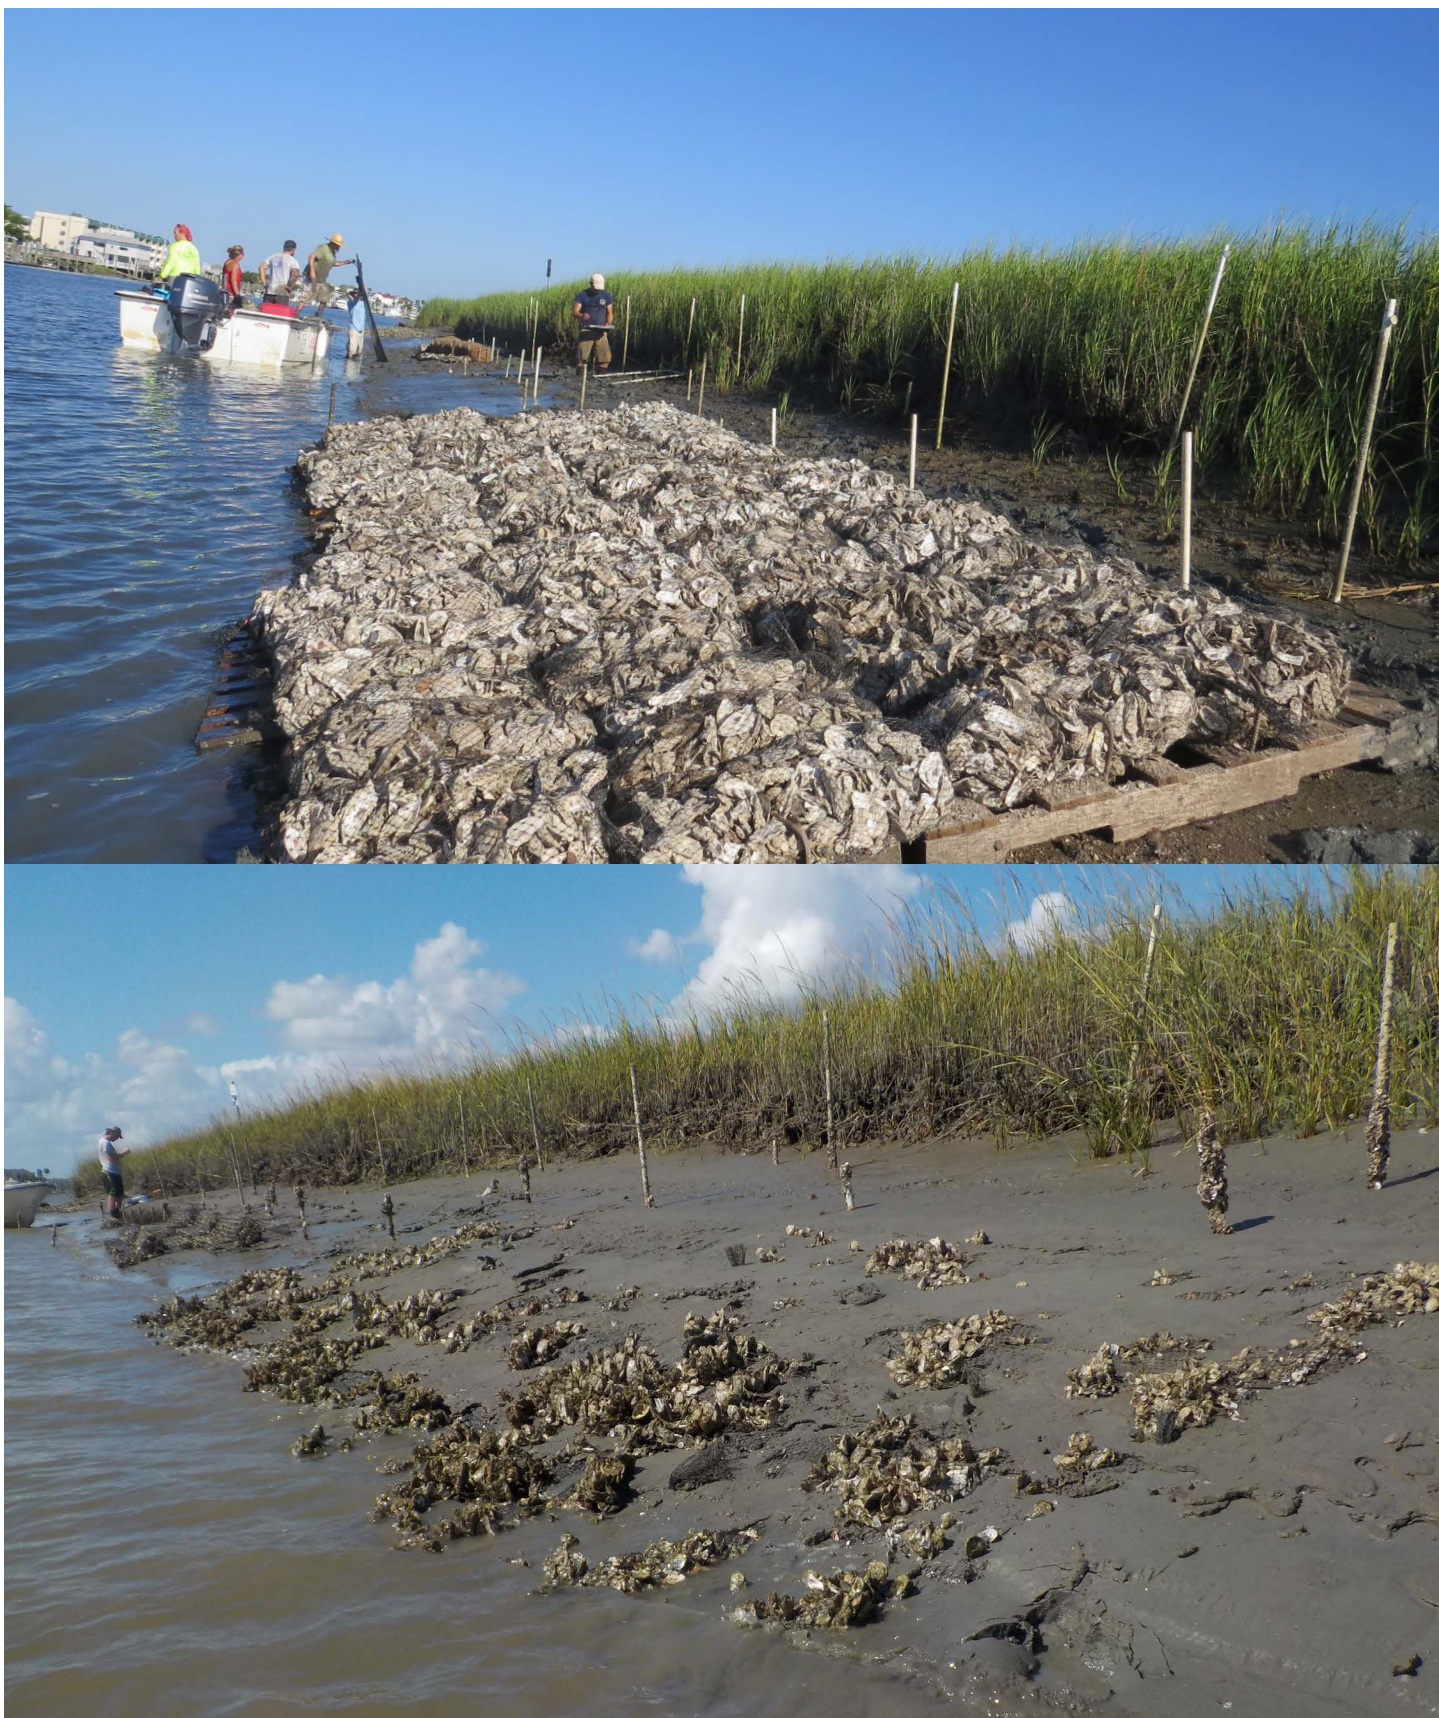
Figure 5.3. Oyster shell bag treatment installed atop wooden pallets in July 2016 along Big Bay Creek (top). The same treatment, a little over a year later (October 2017), with much of its surface area covered with sediment (bottom).
